SHEPHERDSTOWN HISTORIC LANDMARKS COMMISSION

Inspection Report:

General Residential Structural Inspection

339 West German Street

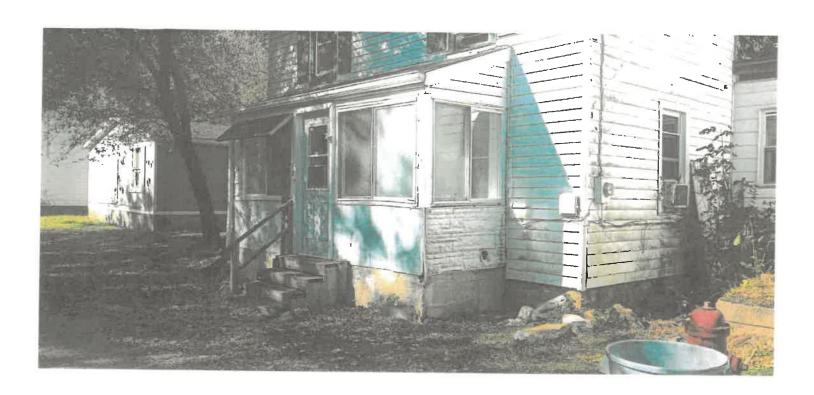
III Ray Street - current porch enclosed

Our plan is to open the porch up similar to its earlier days. Someone has closed the porch with various materials and windows. See picture of existing porch in package. We want to remove these materials and see if the original posts are there to be saved. We would like to keep posts or put new wood posts if nothing is there. See the picture we created in this package. We will replace the front door and jamb on the house with a wood door similar to the time period. This will let so much light into the front two rooms of the house. We will repair / replace existing vinyl siding as needed on the house. The main house has a green metal roof and green shutters. We plan a green metal roof on the porch to tie the porch to the house.
